Manhole Inspection Summary

Manhole # S25C__032MH

Insp Date: **8/3/07 7:29 AM**

Location Address: **1203 MULBERRY ST**

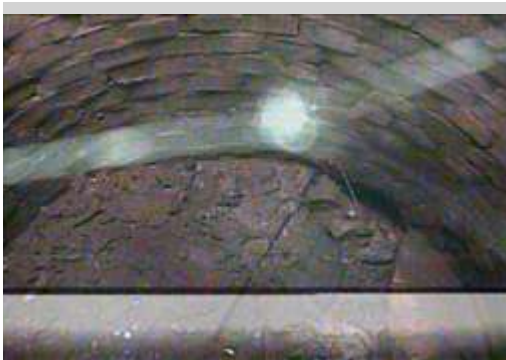
Comments **abandoned pipe at i9**

abandoned pipe at i9

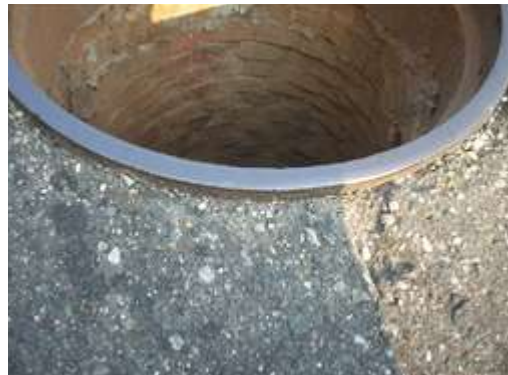
Defect 2

Diameter: **24** (in.) Length: (in.) Dist A/B Grade: **1** (in.)

GRADE ADJUSTMNET

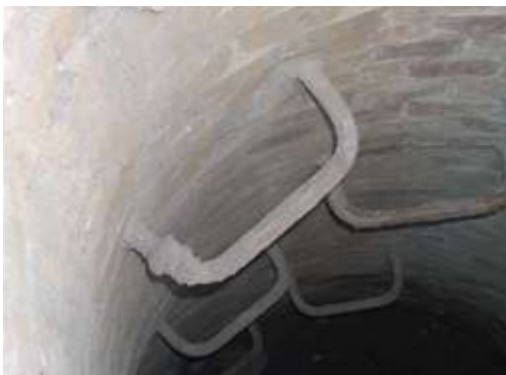
Defect 4

Count: **5** Missing: **0** ☒ **Corroded**

CORRODED STEPS

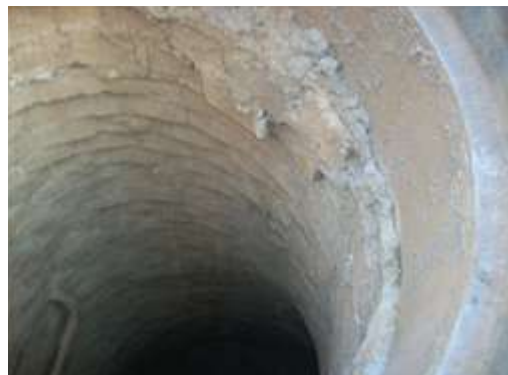
Defect 3

Condition: ☐ Sound ☐ Cracked ☐ Root Intrusion ☒ **Loose Brick** ☐ Deteriorated

LOOSE CORBEL BRICKS

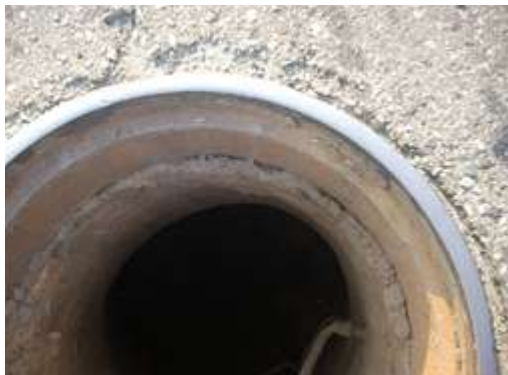
Defect 1

Offset: **1** (in.)

FRAME OFFSET
